**DEL RIO THEATRE  
3300 ATCHISON STREET  
RIVERBANK, CALIFORNIA**

**STRUCTURAL EVALUATION REPORT**

Project Engineer: Casey Lubawy  
Project Manager: Brian Reil, S.E.  
B&B Project No. S08-027.00

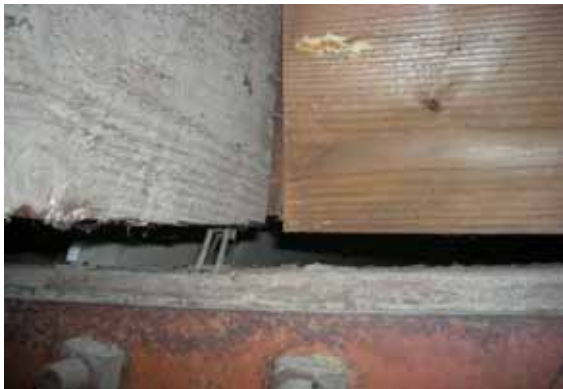
Trusses 1 and 2 were accessed from a ladder removing the ceiling above the second floor offices. The ladder was moved to achieve visual access down the length of the truss. Starting from the South end post to truss connection (connection #1), rust and signs of corrosion are apparent in the steel bucket. Some splitting is present down the vertical post, and splitting was discovered in both sides of the top and bottom chord. Splitting was also apparent in the bottom of the bottom chord. Severe splitting was noticed at connection #2 from the South end on the sides propagating from the bolt line. Connection #3 has splits in line with the bolts, empty holes drilled in line with active bolts, and insufficient edge distance for the bolts. At the first bottom chord splice (from South end) there is a split through the second bottom chord member; there is another split in the bolt line that starts at connection #5 at the bottom chord and runs throughout the entire diagonal to the top bolt connection. There is also a large split around 1/2" in width in the bottom chord at #5. It was noticed that the first three roof joists have roughly 1- 1/2" gap between the bottom of joists and top truss chord; the truss has appeared to sag down and the joists are not bearing. A 3/4" joint is present between the bottom chord and the chord splice member. At connection #3 from the North side there is splitting along the full length each side. There is some settlement at the midspan, similar to the South end, somewhat less severe, causing roughly 1/2"- 3/4" of separation between the top chord and a few roof joists at midspan, along with some separation at the North end and the first few roof joists. There is splitting present at the top chord on each side at connection #2 & #4, and at the bottom chord and diagonals at #3, all similar to the South end of the truss.

**Figure 3 – Non-bearing Separation @ Top Chord & Roof Joist**

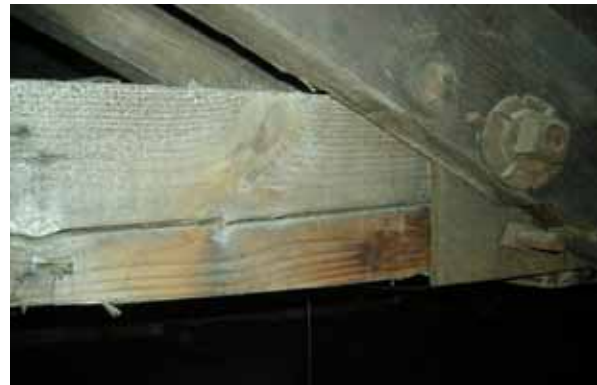
**Figure 4 – Splitting in Bottom Chord**

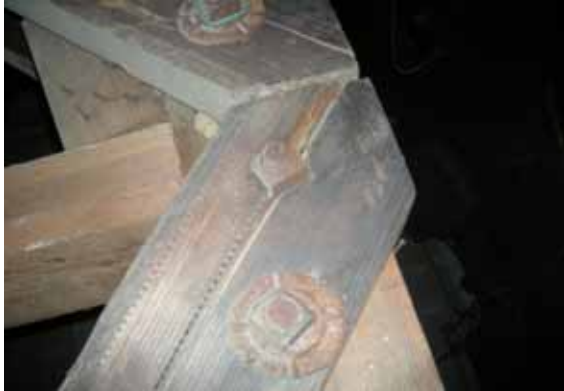
**Figure 5 – Splitting in Diagonal @ Bolts**

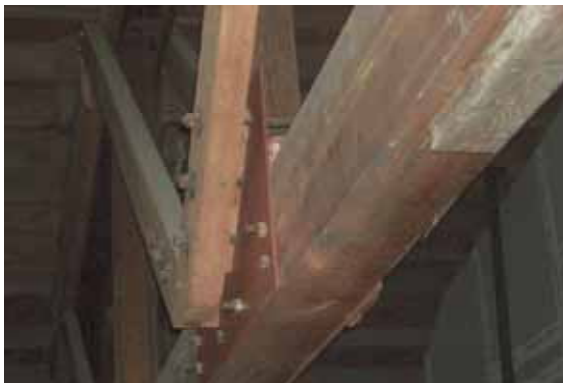
There is a significant amount of rust present at the South connection #1. It appears that there is a 6x post outside of wall plane that is bolted back to the 8x post in line with the 2x8 wall, along with a new cap plate connected to the bottom chord. The entire top chord has additional members laminated to each side. Starting from South connection #1, there is splitting present in both sides of the top and bottom chords in line with the bolts, along with side plate corrosion. No splitting was detected at connection #3. Splitting is present in the bottom of the top chord, particularly around midspan. Two-2x's have been added to each side of the top chord with bolts at 12"cc through much of the midspan. A flat 6x8 has been added to the bottom of the bottom chord for about 10 feet at midspan. A similar gap can be seen between the roof joists and bearing wall East of Truss 2, which occurs for roughly 20 feet around the truss midspan. There is newly added scabbing that fills the depth for a missing diagonal (second diagonal from South); it appears that the existing diagonal was removed and replaced on one side only, leaving a large gap (roughly 3", or two -2x's) between the new diagonal and the existing bottom chord at connection #3 where the bolts are cantilevering. There appears to be a newly added 1/4" plate on the face of the bottom chord at this connection. At connection #1 on the North side, the bottom chord appears undamaged. There is a large split on the sides of the top chord at connection #1 in line with the bolts, and the post here is also sticking outside of the wall plane. The first few roof joists again don't appear to be bearing directly on the top chord here as well.

**Figure 6 - Separation @ (n) Vertical and (e) Bottom Chord**

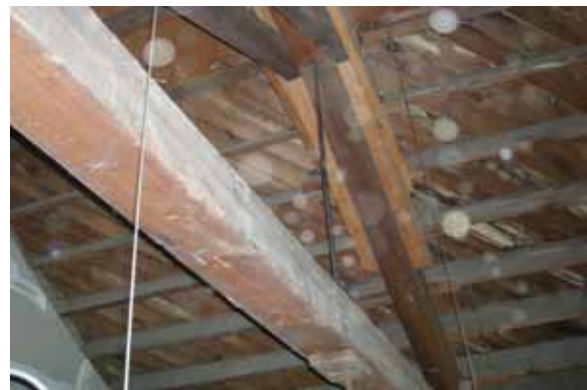
**Figure 7 - Repair @ Top Chord**

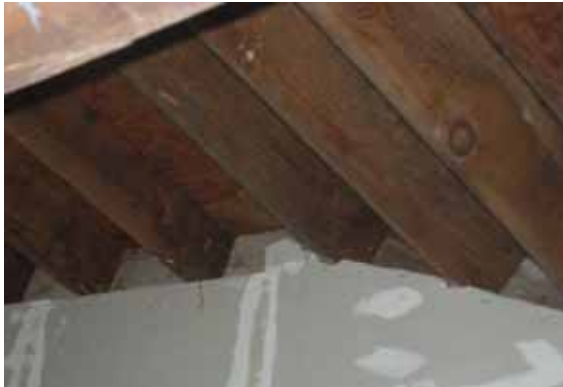
**Figure 8 - Separation @ Roof Joists and Bearing Wall**

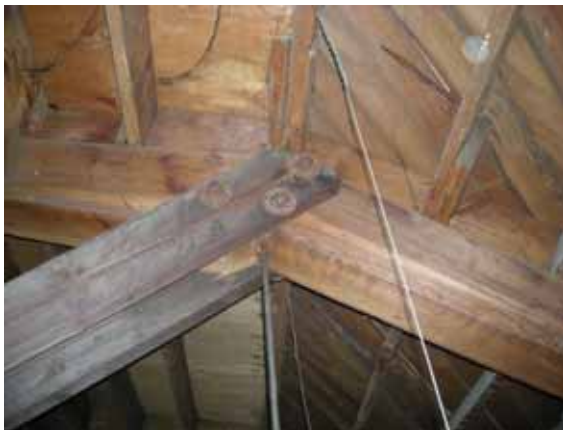
Trusses 3 through 6 were evaluated with the use of a lift; typically a minimum of three locations were inspected (North, midspan, and South ends) to achieve a full inspection. At Truss 3, the first vertical from the North side has significant visible water damage. The first diagonal connection #2 has severe splitting, with a width greater than 2" wide in the top chord and 1/2" in the diagonal. The bottom chord at the North end has splitting on each side with widths up to 1/2". Newly added members have been added at the truss midspan (roughly 10 feet in length, 5 feet each side of center of truss) with 7/8" diameter thru bolts spaced roughly at 12" on center at Truss 3, 4, and 5, consisting of a flat 6x8 under the 8x8 bottom chord with 2-2x6 ea side, top and bottom, of the 8x8, along with a new 1/4" plate on each side with 9- 3/4" diameter newer bolts and 4- 7/8" diameter reused bolts. The vertical rod at the North side is bent and appears to have failed.

**Figure 9 - Severe Splitting in Top Chord and Diagonal**

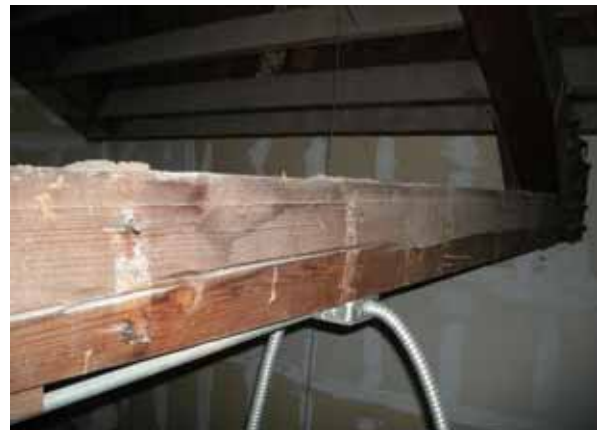
**Figure 10 - Bottom Chord Splitting**

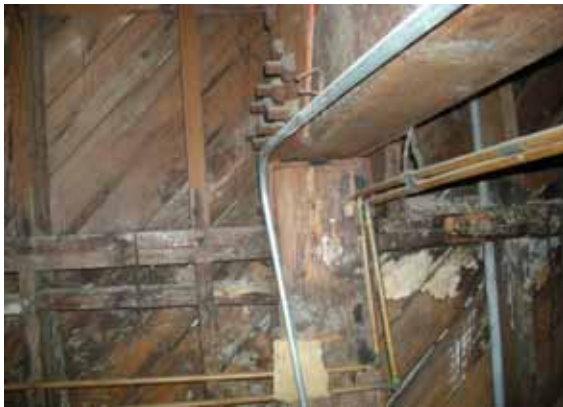
The same repair is present at the bottom chord as in Truss 3. Starting from the South end, there is significant water damage present at the wall studs. There is splitting in the bottom chord on the sides in line with the top row of bolts at connection #1, splitting in the top chord in line with the bottom row of bolts in #1, and splitting in the sides at the top chord at connection #2 in line with the bolts. There is no apparent gap between the roof joists and the top chord. Over at the North end there is splitting at the first top joint similar to that at the South but not quite as significant.

**Figure 11 - Double Top Plate (hinge) at Truss and Water Damage**

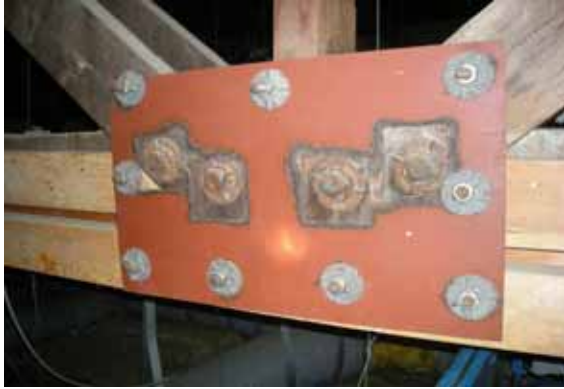
The same retrofit scabbing is present at the midspan of Truss 5 as in Truss 3 & 4. The repairs conceal much of the damage present in the original bottom chord. The new  $\frac{1}{4}$ " plate at the center of this newer repair is roughly 30" wide x 18" tall with  $9\text{-}\frac{3}{4}$ " diameter bolts and  $4\text{-}\frac{7}{8}$ " diameter bolts, encompassing all of the newer retrofit members and bottom chord. There is occasional splitting in the top chord at the South end. At the North end there is more significant splitting in the top and bottom chords in line with the bolts at the heel connection.

**Figure 12 - (n) Steel Plate and Repair @ Bottom Chord**

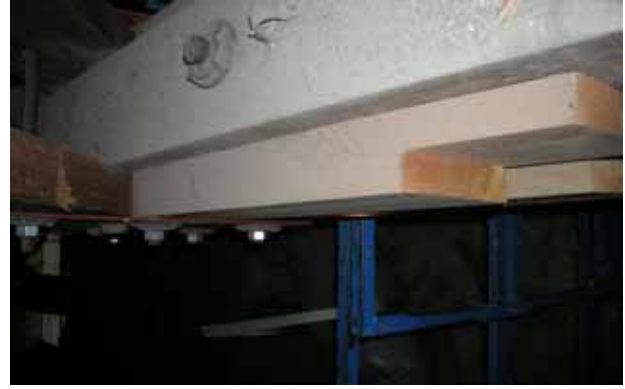
**Figure 13 - Side View of (n) Repair at Bottom Chord**

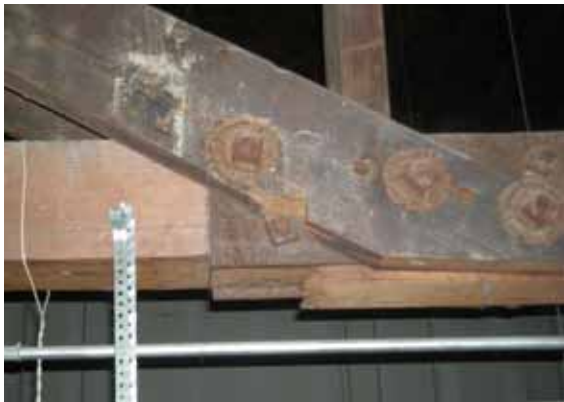
Truss 6 was accessed from below from a ladder set on the East end of the stage. There is significant water damage at the South-East corner. Wall studs, double 2x wall top plate, and roof joists show excessive signs of water damage. There is negligible splitting visible at the bottom chord at the South connection #1; however there is some splitting on the sides of the top chord at connection #2. There is splitting on one side of the bottom chord that running to about midspan. At midspan there is splitting at connection #5 in the diagonal member in line with the bolts. Scabbing repair is present at midspan similar to previous. There is no apparent splitting in the top or bottom chord. At the North end there was splitting on the side of the bottom chord on down to the midspan, along with splitting at the top chord connection #2 in line with the bolts. The bolts at this connection appear to be loose and the nuts could be unscrewed by hand.

**Figure 14 - Bolt not in Diagonal**

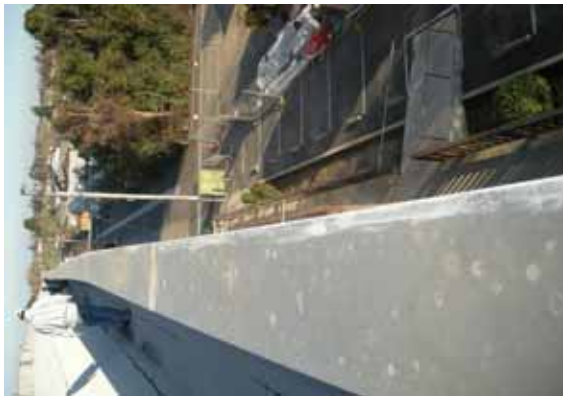
Bowing of the South exterior wall was discovered in the interior sheet rock and exterior plaster systems most predominantly at Truss 4. From the inside, many wall studs and diagonal sheathing show signs of water damage. There are about 6 newly added 2x6 studs between Truss 3 & 4 that are in the same plane as the 2x8 wall studs, essentially replacing the original 2x8's

**Figure 15 - Rooftop View of Bowing in South Wall**

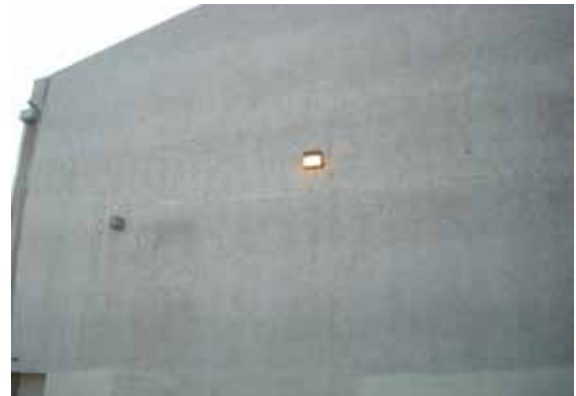
**Figure 16 - East Exterior Elevation w/Horizontal Crack in Plaster**

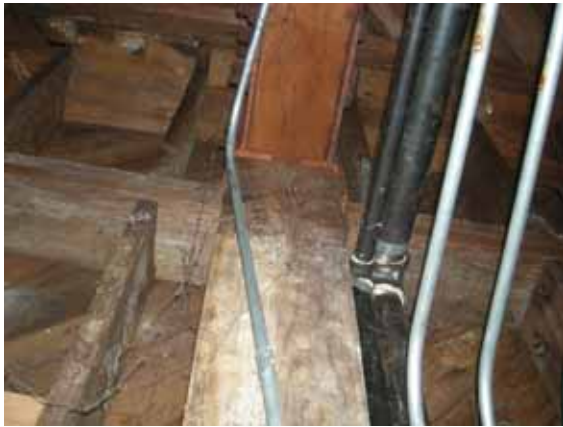
that had significantly rotted away. From the top of the soffit above the existing ceiling up for about five feet there is no diagonal sheathing on the wall studs. The double 2x top plate spans horizontally at the soffit between truss posts with no positive connection, creating a hinge near the top of the wall and thus making the wall unstable. Anchor bolts potentially present at the existing sill plate were concealed, and the 8x10 posts at the trusses appear to be toe-nailed (4-5 nails) to the sill, and the post had slightly rotated at the base. The wall studs span vertically roughly 24' to a double 2x top plate that spans horizontally between truss posts. There is no positive connection between the double top plate and posts, and many of the studs on the South and East walls, particularly toward the SE corner, along with the double top plate show severe signs of water damage. The 2x8 studs extend above the double top plate roughly another 10'. The 2x8 wall was inspected at midheight at Truss 4, where wall deflection was most apparent, between the double top plate and finished floor. There is a large visible horizontal crack in the plaster on the outside of the building at the double top plate location on the South wall, along with the same type of crack at the outside of the East wall (the double top plate at the East wall appears to be lower at roughly 14' above finished floor. Upon removal of the sheetrock it was apparent that there were large portions of diagonal sheathing missing or rotted away, leaving the plaster with a separation (up to 1- 3/4" wide) from any connectivity. There are many studs above the double top plate that have been replaced and many others that show severe rot. The double top plate has severe water damage; water damage is greater in the plate and studs heading towards the South-East corner of the building.

**Figure 17 - Interior View of Double 2x Top Plate w/no Connection to Post**

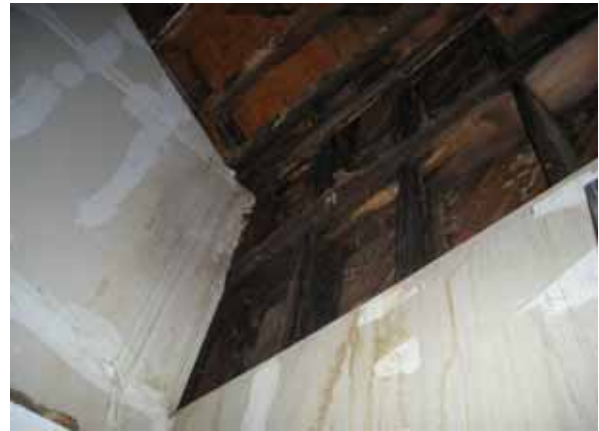
**Figure 18- Interior View of Water Damaged Framing @ South/East Corner**

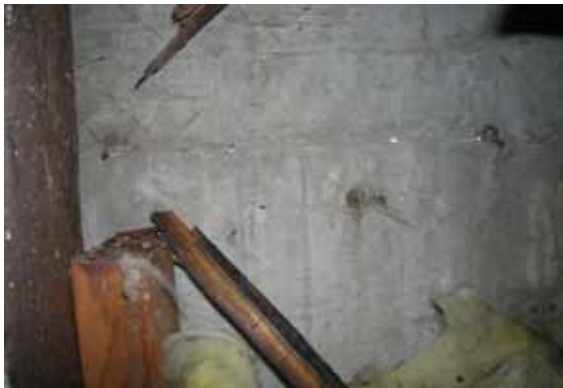
**Figure 19 - Figure 18 - Interior View of Exterior 2x8 Wall w/Missing Sheathing and Delaminated Plaster**

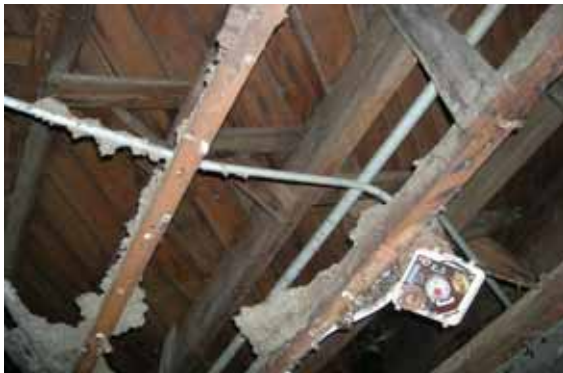
The framing over the Banquet Hall #2 was viewed from a ladder by removing the suspended ceiling panels. Starting from the South side (wall adjacent to Banquet Hall #1), there are 2x12 roof joists spaced at 16" on center supporting 2x4 ceiling joists that are hung down. The roof joists span between interior 2x bearing walls and have diagonal sheathing on top. It was apparent that an original hard-lid gypboard ceiling with insulation was attached to the bottom of the 2x4 joists. Some signs of water stains and damage is present in the roof joists and diagonal sheathing, most predominantly toward the storage and walk-in refrigerator rooms (towards the South East). There is also significant rotting in the sheathing where a pipe has penetrated through the roof sheathing and allowed water to leak in. The bearing studs in the South wall of the Banquet Hall show water damage. The interior walls on the South and West sides of the area have damaged and in some areas not present sill plates. At the North side storefront there is diagonal sheathing on the exterior side up to the ceiling level over 2x6 studs with gypboard on the inside and then plywood on the inside of that. Nailing above the ceiling connecting the plywood and the wall studs and the plywood to wall double top plate from the inside above the ceiling could not be verified. The plywood at the bottom of the wall was cut away, exposing the interior wall studs from inside the room. There was only one anchor bolt present down the entire North wall line. There was severe water damage present in the studs and roof framing above the ceiling at the North East corner of the room, along with mold and mildew visible on the wall and floor tiles.

**Figure 20 - 2x12 Roof Joists with Suspended 2x's  
& Remnants of Previous Ceiling**

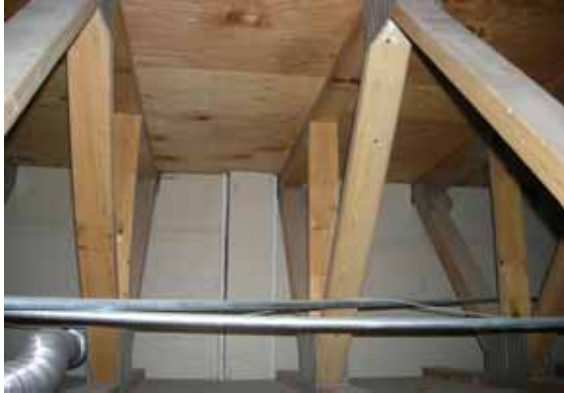
The second floor framing was inspected by ladder by removing the ceiling panels from below. The trusses show no signs of water damage and are in good overall shape. There was no apparent connection between the interior 2x4 partial height second floor bearing wall and the full height exterior 2x8 studs.

**Figure 21 - 2nd Floor Office Gang-Nail Truss Framing**

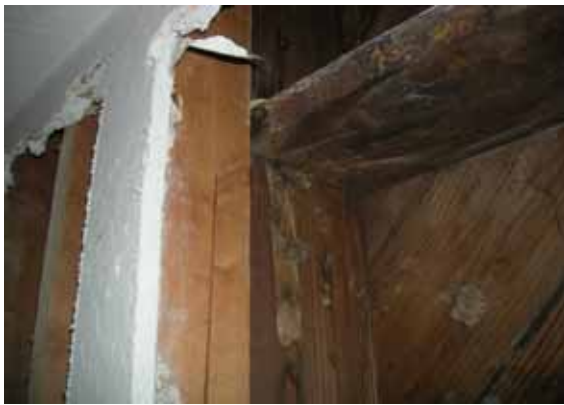
**Figure 22 - Interior View of 2x4 Bearing Wall @ Office Truss & Exterior 2x8 Wall**

The second floor framing consisted of 2x4 gang-nail trusses, roughly 3' in depth, spaced at 24" on center, spanning between 2x4 interior bearing walls. These trusses show no signs of water damage and are in good overall shape. There was no apparent connection between the interior 2x4 partial height second floor bearing wall and the full height exterior 2x8 studs. The interior walls appear to only have gypboard and are lacking plywood or diagonal sheathing. A lateral system consisting of sheathing and possibly holdowns would need to be added to the office framing walls wherever not present. See Appendix D for photos of the second floor framing.
