**DEL RIO THEATRE  
3300 ATCHISON STREET  
RIVERBANK, CALIFORNIA**

**STRUCTURAL EVALUATION REPORT**

Project Engineer: Casey Lubawy  
Project Manager: Brian Reil, S.E.  
B&B Project No. S08-027.00

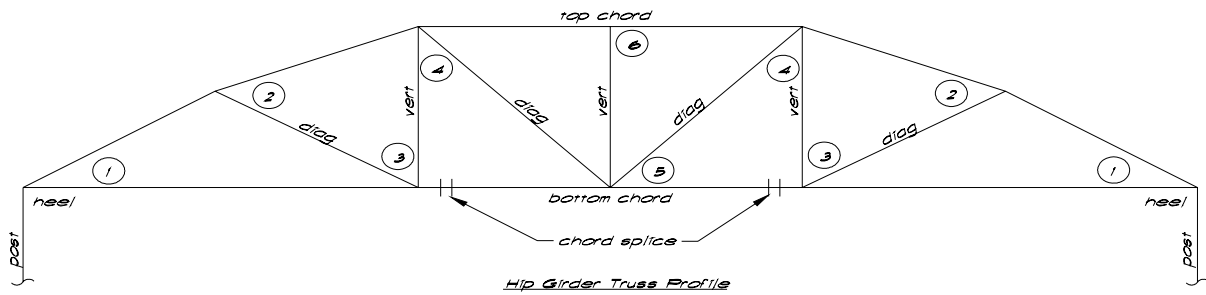
Figure 1 - Truss Profile

At the main Banquet Hall (Banquet Hall #1) / Assembly Area, there are six total hip girder roof trusses, spaced at about 20' on center (see Fig.1). The trusses have been numbered for reference, starting with Truss 1 at the far West end above the second floor offices (Truss 2 is also above the offices) and Truss 6 at the far East end above the stage.
